# Manhole Inspection Summary

Manhole # S23A\_\_026MH

Insp Date: **7/27/07 7:11 AM**

**Location** Address: **608 VINCENT ST**

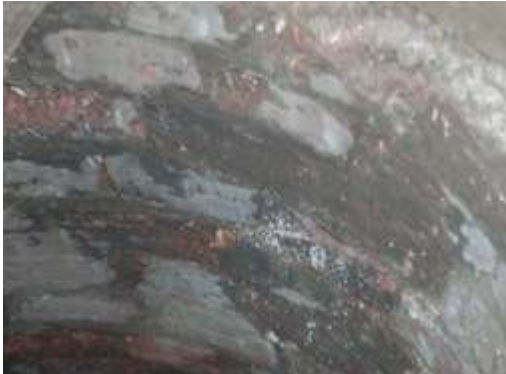
Defect 4

Infiltration: ☐ None ☐ Joint ☒ **Cracks** ☐ Mortar ☐ Roots ☐ Wall

CORBEL INFILTRATION AT CRACKS

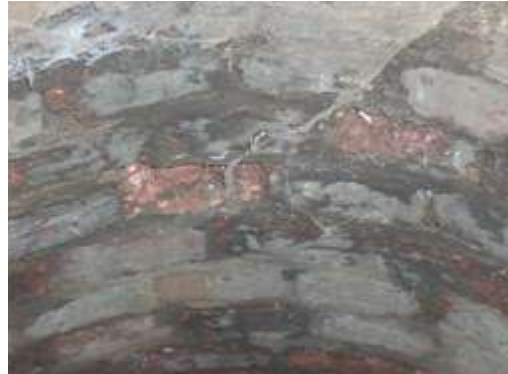
Defect 3

Condition: ☐ Sound ☐ Cracked ☐ Root Intrusion ☐ Loose Brick ☒ **Deteriorated**

DETERIORATION OF CORBEL

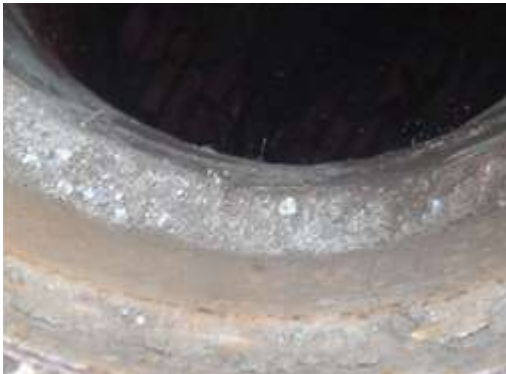
Defect 2

**Frame** Offset: **1** (in.) Condition: ☒ Sound ☐ Cracked ☐ Leaks

FRAME OFFSET

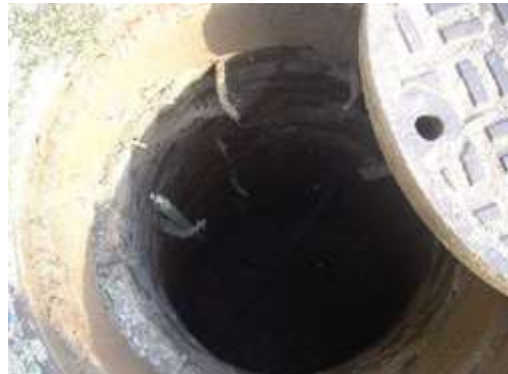
Defect 1

**Steps** Count: **0** Missing: **5** ☐ Corroded

5 MISSING STEPS

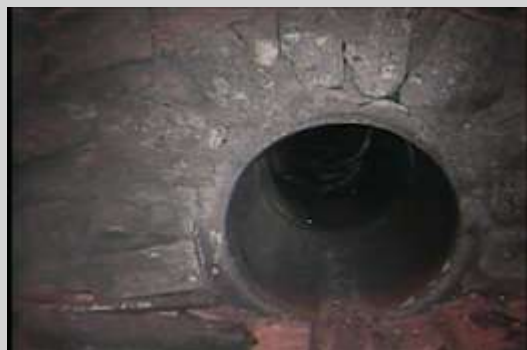
12 O'Clock Outflow

8 in. Circular Gravity Sewer  
Pipe Out @ 12 O'Clock

Pipe Height: **8.4** (in.) Rod and Bar (Angled)

Pipe Material: **Clay** ☐ Pipe Lined

Invert Depth: **9.34** (ft.) Flow Characteristics: **None**

Deposits: ☒ None ☐ Mud ☐ Sludge ☐ Debris ☐ Grease

Infiltration: **None** Pipe Seal Cond: **Sound**
